# FINAL FEASIBILITY STUDY (13408B)

**Interstate 95 Bridge over the Taylor River (NHDOT No. 120/102)  
and Taylor River Pond Dam (NHDES No. 106.08/.09)  
Hampton Falls, Hampton, NH**

**June 25, 2010**

**THE LOUIS BERGER GROUP, INC.**  
1001 ELM STREET, SUITE 203  
MANCHESTER, NH 03101  
(603) 644-5200

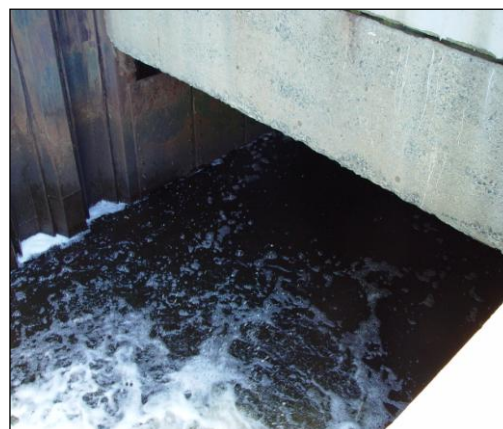
Upstream face of I-95 Bridge

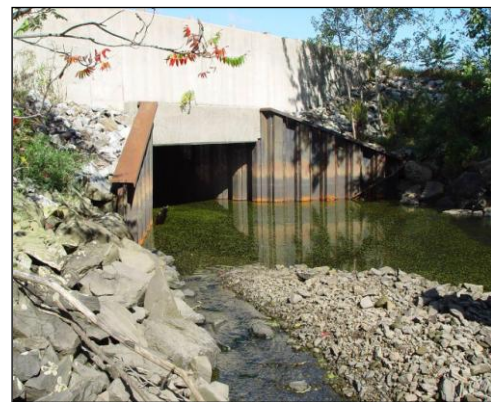
Downstream Face of I-95 Bridge

The existing bridge structure is approximately 207 feet long (measured along the relocated Taylor River) and provides a clear opening width of 15 feet. It is comprised of vertical steel sheet piling supporting a cast-in-place reinforced concrete slab and approximately six to eight feet of roadway fill. The NHDOT Bridge Inspection Reports note that the steel sheet piling is heavily rusted with section loss and holes below the waterline. The reinforced concrete slab shows cracking and spalling, and is leaking. The bridge rail, rail transition and approach rail ends do not meet current standards.

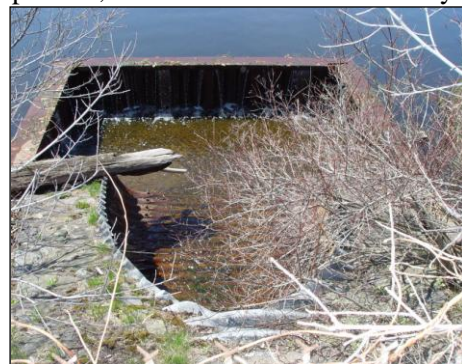
Emergency Spillway and  
Entrance to Culvert

4. Emergency Spillway/Culvert (NHDES Dam #106.09): The Taylor River Pond emergency spillway is a 35.5 foot long by 1.5-foot-wide sheet pile structure with a spillway elevation of 9.03 feet that flows into a 6.1-foot-high by 8.8-foot-wide steel plate pipe-arch culvert. The pipe-arch culvert carries excess water under the I-95 roadway south of the bridge and spillway location. As stated above,

discharge through this culvert attracts migrating fish during high flows. However, fish are stranded either immediately below the emergency spillway or in the culvert when the water level recedes. This spillway is considered a “Significant Hazard Dam” by the NHDES Dam Safety Bureau. A new concrete invert was recently constructed as a measure to repair the deteriorated culvert invert. The interior dimensions were reduced to a height of 5.66 feet and a width of 7.98 feet.

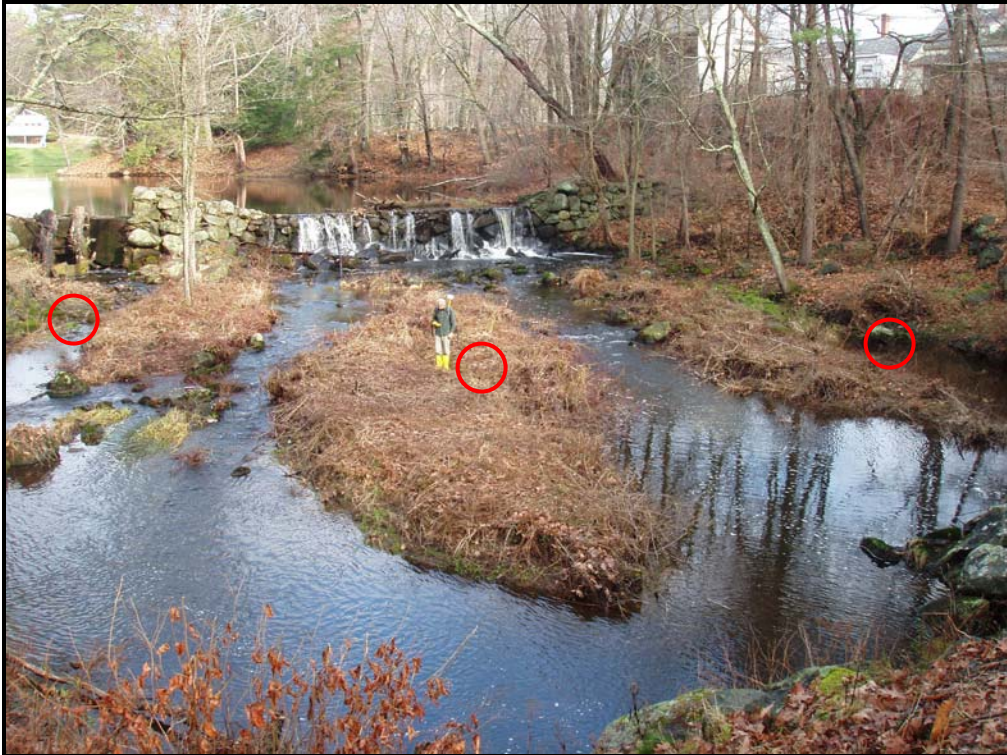
**Figure 18: Sediment Sampling Station TR-S1 Location (View 1)**

[Looking to the northwest from Old Stage Road bridge. Three subsamples were collected: 1 of 3 (right side), 2 of 2 (center), and 3 of 3 (left). Rice Dam is in the background.]

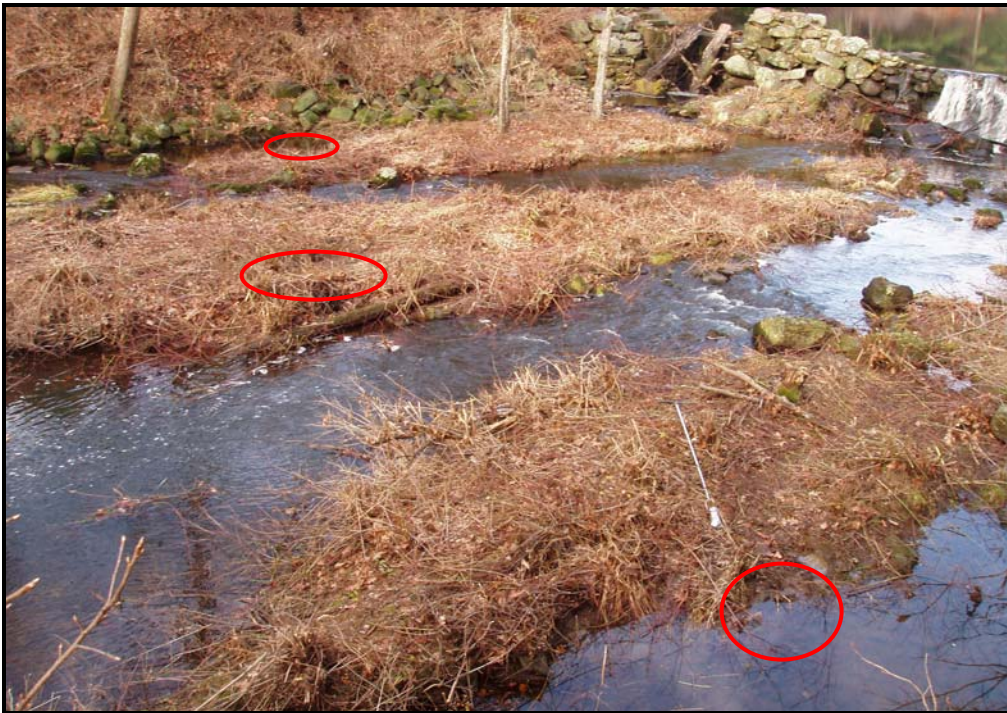
**Figure 19: Sediment Sampling Station TR-S1 Location (View 2)**

[Looking west from the northern shore. The three subsamples are again marked: 1 of 3 (foreground), 2 of 2 (center), and 3 of 3 (background). ]

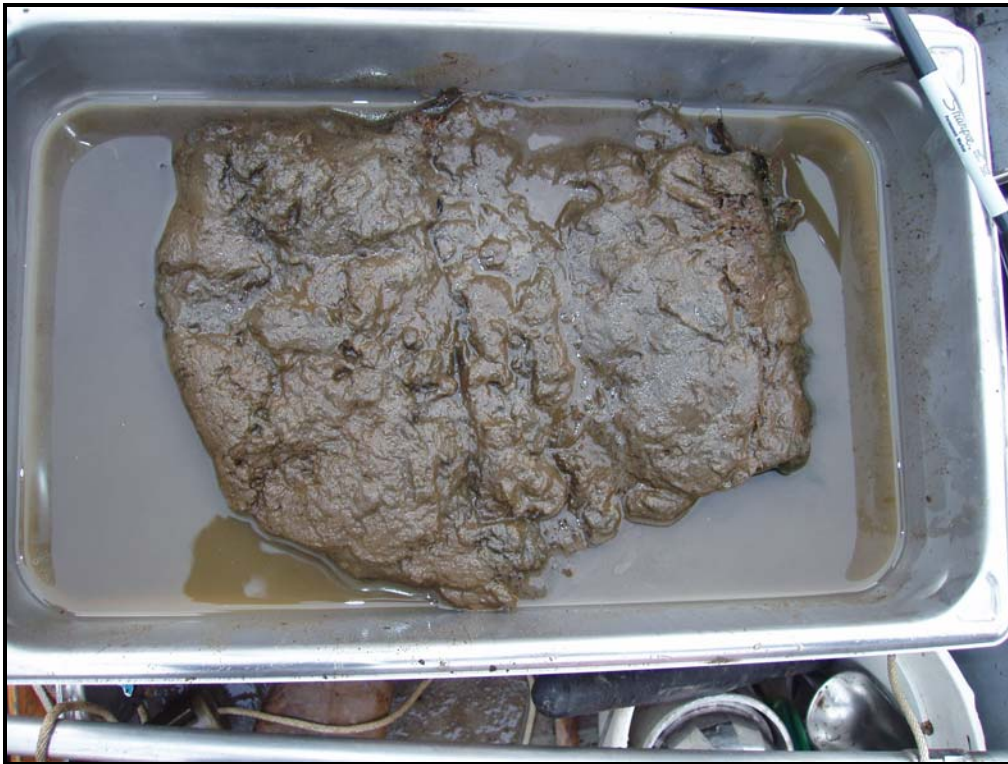
**Figure 21: Sediment Sample Taken from TR-S2  
(Sub-Sample 3 of 3)**

[Fine-grained sediment collected from the upper 7 inches at  
Station TR-S2.]

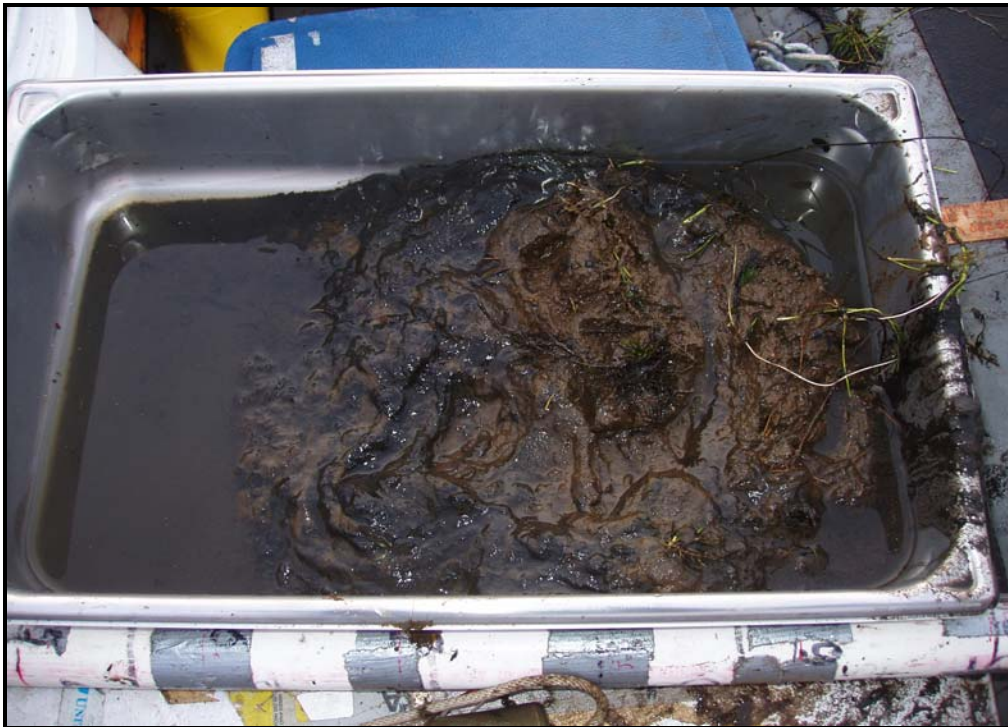
**Figure 23: Sediment Sample Taken from Station TR-S5  
(Sub-Sample 1 of 2)**

[Fine-grained sediment collected from the upper 7 inches at Station TR-S5. The sediment contained hardly any vegetation such as roots.]

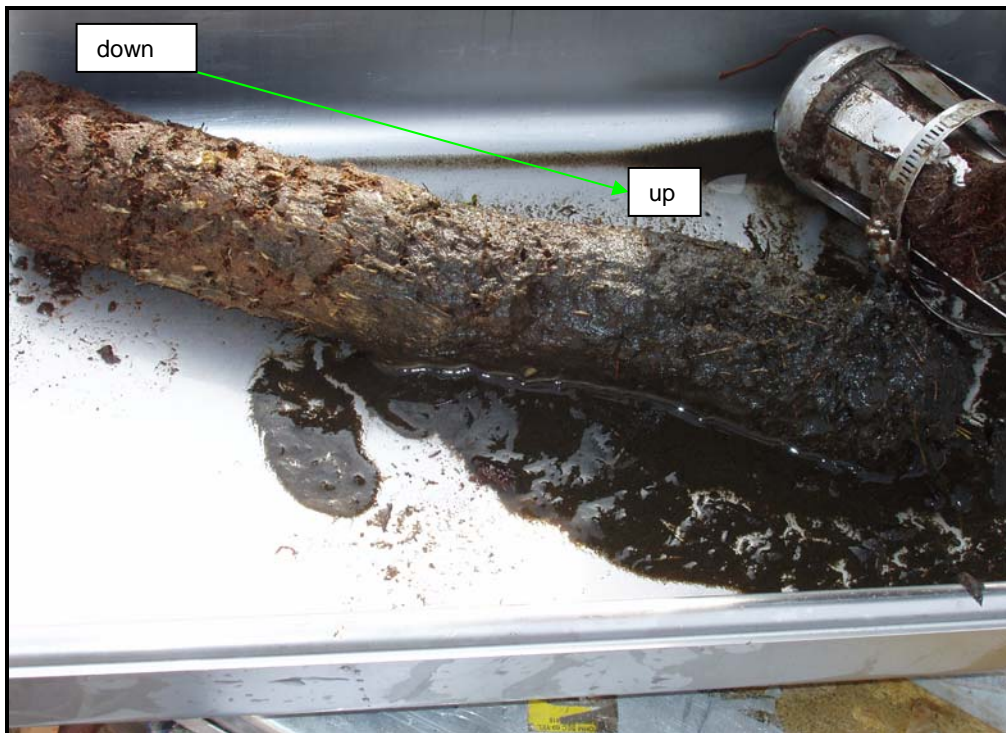
**Figure 24: Sediment core at Station TR-S5**

[Collected by core from underneath the upper fine-grained sediment layer. The sediment contained a high density of vegetation and likely represents the pre-impoundment marsh surface.]

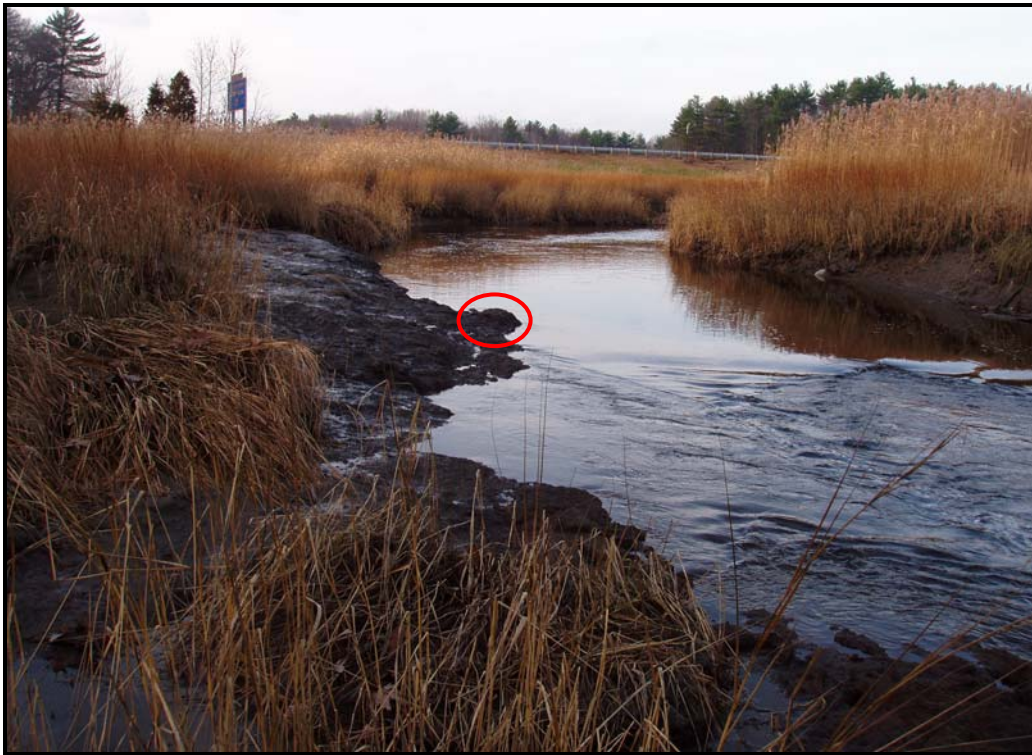
**Figure 26: Sediment Sampling Station TR-S4 (Sub-Sample 2 of 3)**

[View 1 - Looking to the west.]

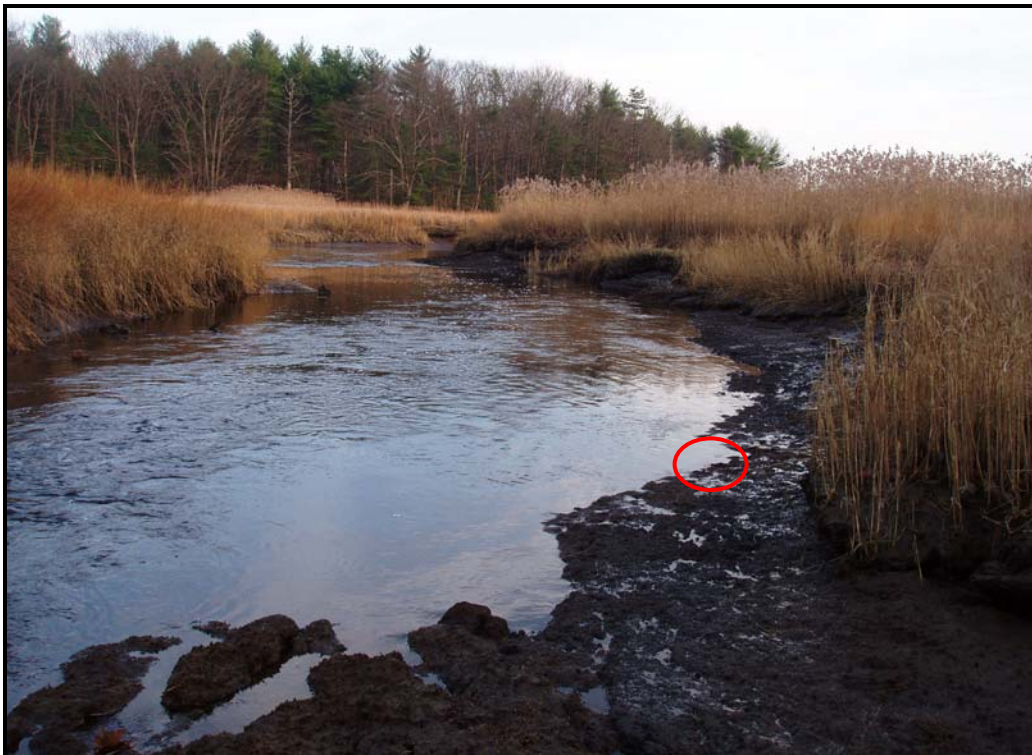
**Figure 27: Sediment Sampling Station TR-S4 (Sub-Sample 2 of 3)**

[View 2 - looking to the east.]

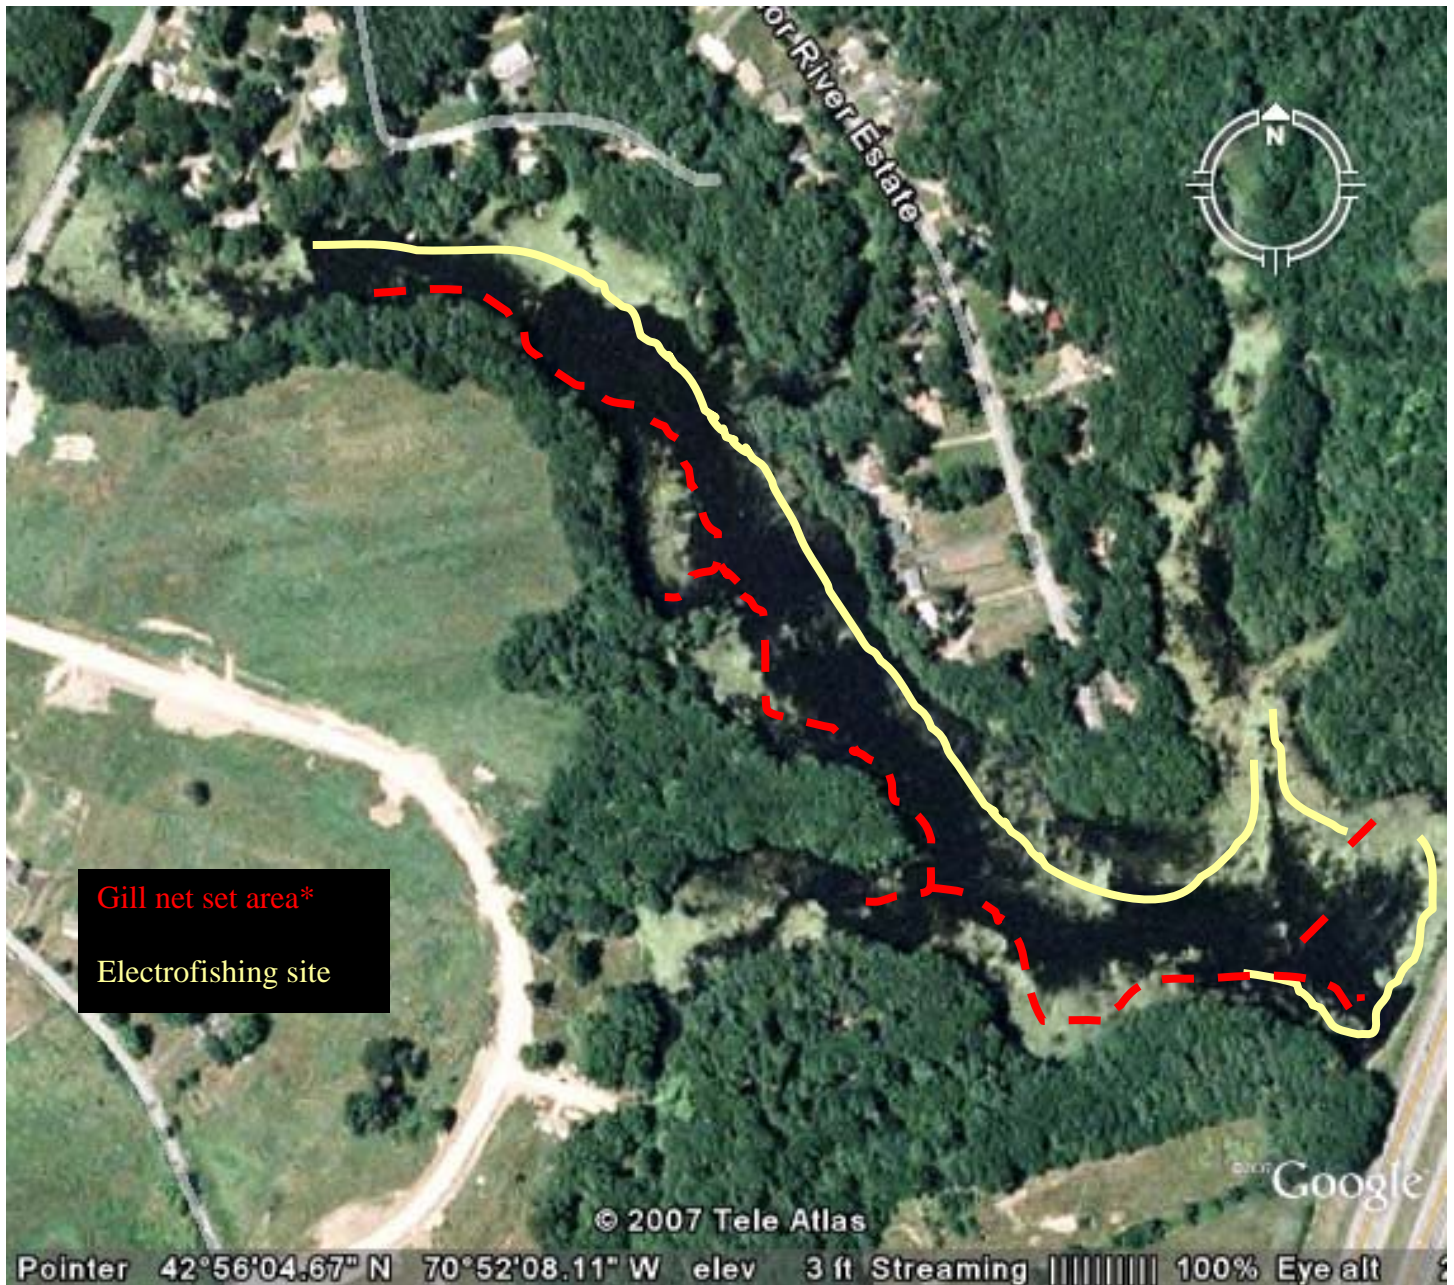
**Figure 29 - Gill net and electrofishing boat fish sampling areas for public and wildlife risk assessment sampling in the Taylor River Pond in 2007, Hampton-Hampton Falls, NH.**

*\* The area designating gill net sets only indicate general area of positioning and not true positions.*

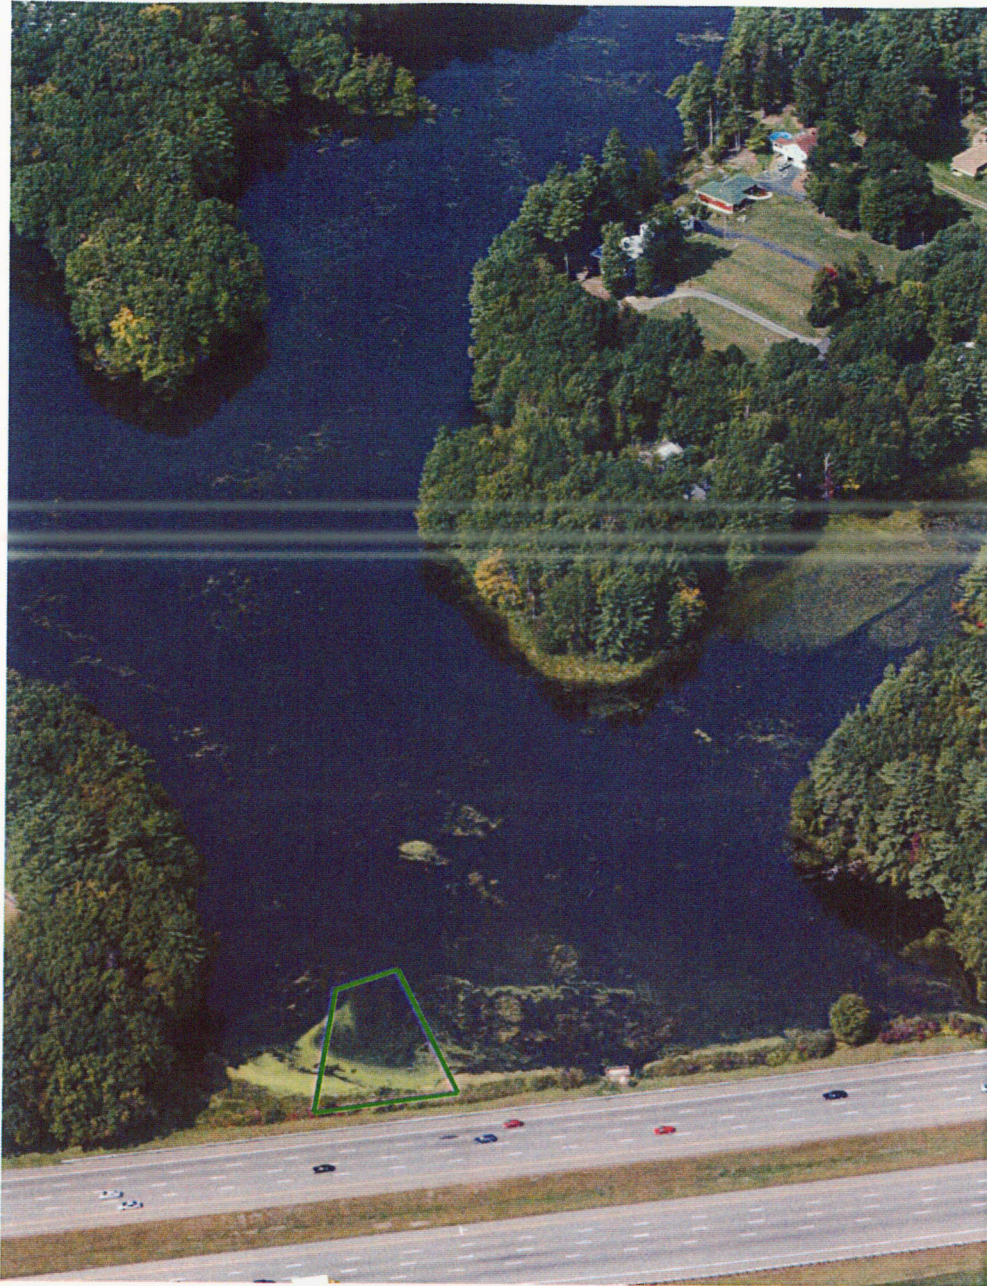
**Figure 2:** Taylor River Pond, with approximate area of excavation for Alternative B.

We recommend the removal of a trapezoidal-shaped apron with a length of 160 feet, and widths of 140 feet along the downgradient side and 60 feet along the upgradient side (Figure 2). This apron includes the 60-foot long and 70-foot wide area of construction for the proposed new spillway and fishway. The remaining 100 feet are excavated to prevent potential resuspension of sediment, and to clear the area for the heavy equipment for the construction of the new spillway.

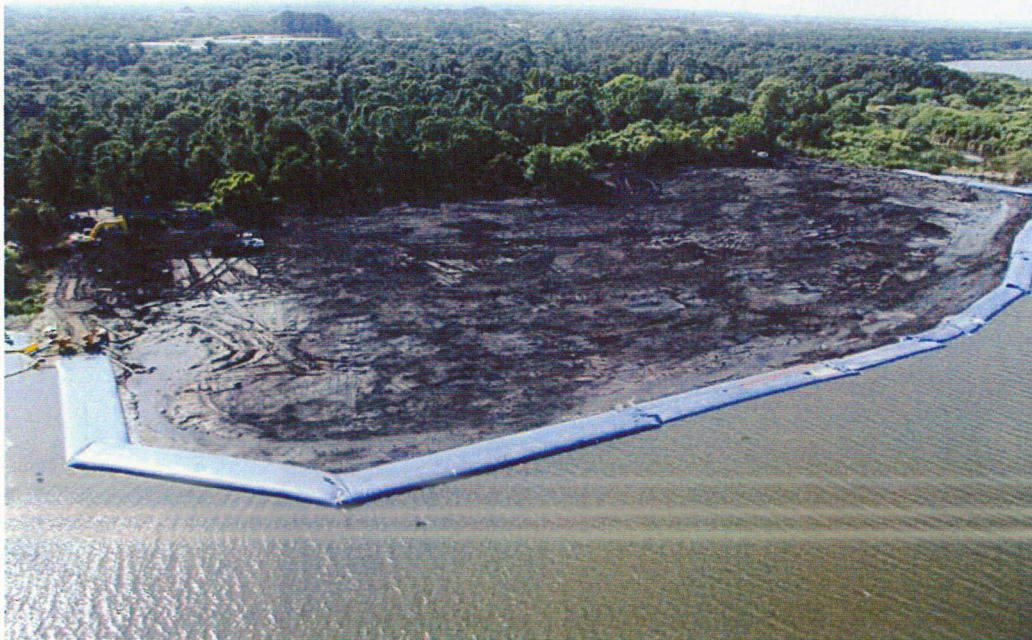
**Figure 3:** Example of portable cofferdams (Aqua Barrier™) used for work in a pond (Source: <http://www.aquabarrier.com>).

- **Excavation:** The surface sediment would be excavated from the suggested trapezoidal zone (or another zone with redesigned dimensions) within the partially dewatered pond. Excavation would best be conducted in the dry, or at least in standing water, to avoid transport of the resuspended sediment into the downstream estuary. Dry conditions in the excavation area could be achieved with temporary berms placed into the channel and with portable cofferdams (*i.e.*, Aqua Barrier™ or equivalent), as appropriate. Aqua Barriers are modular water-filled cofferdams (Figure 3).

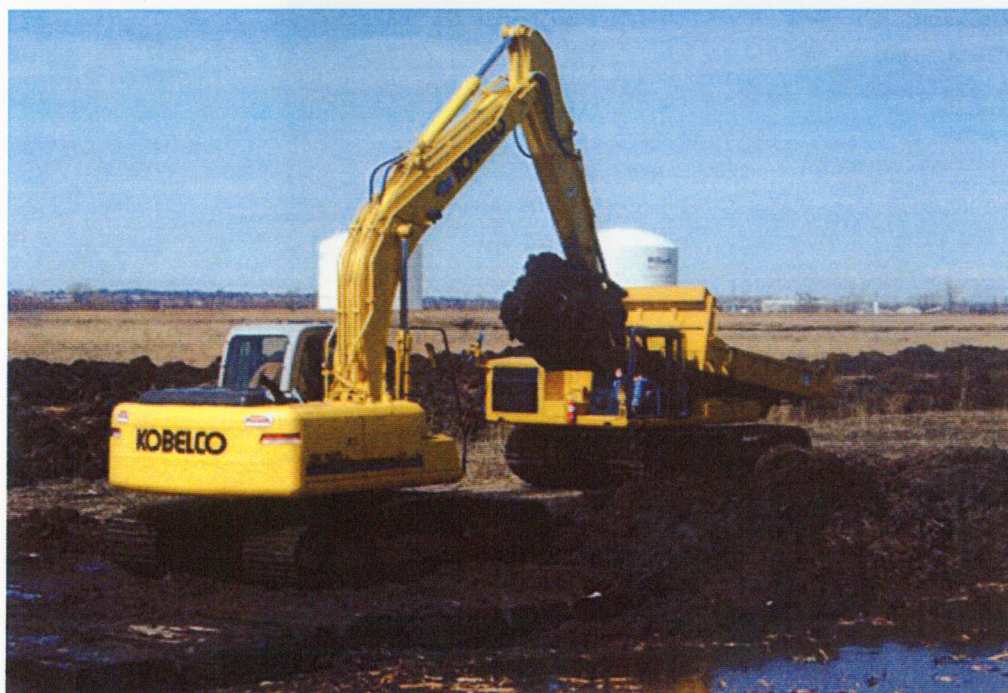
**Figure 4:** Example of timber matting with excavator and low ground pressure truck, operating in a marsh restoration project (Source: The Louis Berger Group, Inc.).

Track-mounted excavation equipment (excavators, trucks) would move on timber-matting or other types of sturdy matting to prevent sinking into the substrate (Figure 4). It may also include the use of a low ground pressure excavator and truck for transport from the excavation location to a laydown area. The excavator may use a longer arm attachment to increase the reach of the equipment to properly extend into the tidal channel and minimize the repositioning of timber mats.

As for Alternative B, track-mounted excavation equipment (excavators, trucks) would move on timber-matting or other types of sturdy matting to prevent sinking into the substrate (Figure 4). It may also include the use of a low ground pressure excavator and truck for transport from the excavation location to a laydown area. The excavator may use a longer arm attachment to increase the reach of the equipment to properly extend into the tidal channel and minimize the repositioning of timber mats.

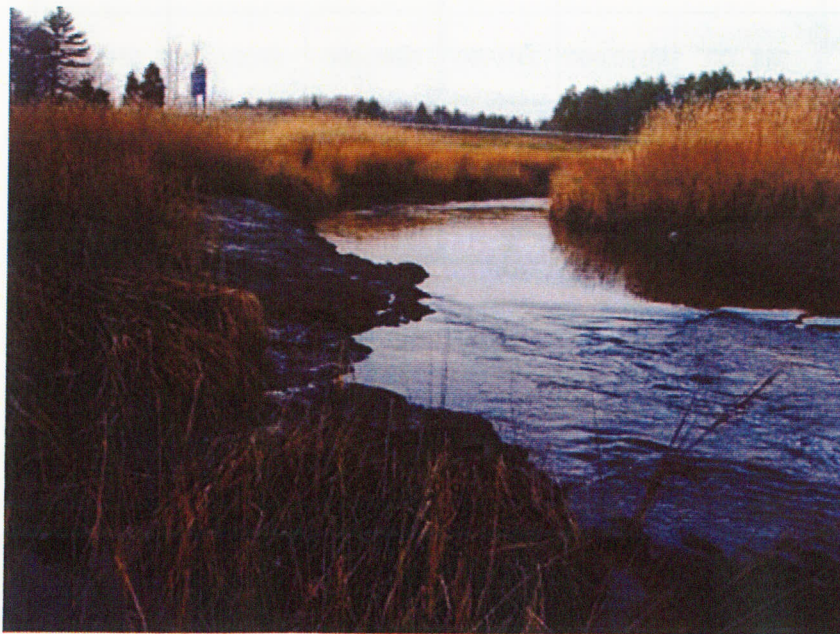
**Figure 6:** Taylor River estuary, just downstream of the Taylor River dam. The width of the tidal creek channel and mudflat ranges from 25 to 40 feet.

The dredging area determined by NHDES is shown on Figure 1. Alternatively, the area proposed by NHDES could be narrower, such as 50 feet instead of 100 feet, based on the dimensions observed in the estuary just downstream of the dam (Figure 6). At the same time, the length of the area proposed by NHDES (*i.e.*, 1,000 feet) only extends halfway to the sampling transect TR-S2 (Figure 1); thus the length could be doubled. Revising the shape in this manner is recommended as most of the sediment that is expected to be mobilized will come from the currently submerged tidal creek channel. Revising the shape of the excavated area would result in a commensurate net volume of excavated sediment.

- **Excavation:** The surface sediment would be excavated from the required zone (1,000 x 100 x 1.5 feet; or another zone with redesigned dimensions) within the dewatered pond. The excavation would intend to replicate the dimensions of the channel that exists downstream of the dam (Figure 6). Excavation would best be conducted in the dry, or at least in standing water, to avoid transport of the resuspended sediment downstream estuary. This could be accomplished by bypassing the river around the area of excavation. Bypassing could be done in sections, using temporary berms placed into the channel and portable cofferdams (*i.e.*, Aqua Barrier™ or equivalent), as appropriate (Figure 3). River water could be pumped around the isolated excavation area as needed. Alternatively, a temporary channel could be dug parallel to the original channel, after the surface sediments (containing pesticides) were removed for appropriate disposal. Such a temporary channel could be much smaller than the original channel, as it would only be required to accommodate low summer flows.

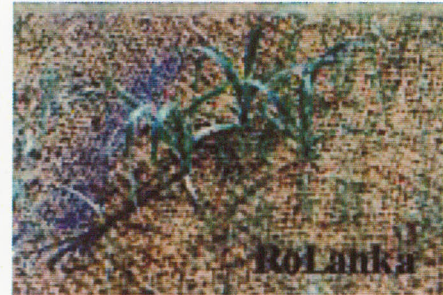
- **Coir mats:** Parts of the tidal marsh could be stabilized further using coir (coconut) mats. These mats could be spread over seeded areas, or plants could be planted through them (see example from the firm RoLanka to the right). Alternatively, preseeded mats could be used. The unit price for coir fiber mats is approximately \$5 per square yard for materials and installation. Matting shall be rolls of machine spun bristle coconut fiber woven into a high strength matrix. Matting shall conform to the properties listed in Table 5.

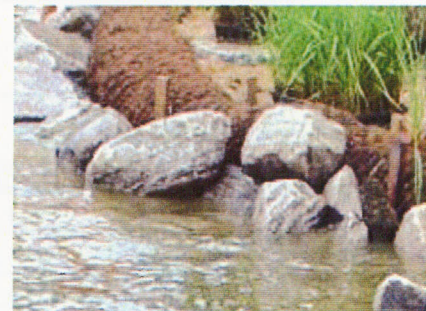
- **Natural Fiber Log (Bio-log):** Bio-logs are also made of biodegradable coir fiber. The logs are effective in reducing flow velocities along edges of banks and in trapping and retaining sediment (see photo on the right from a NOAA restoration project in the Chesapeake Bay<sup>1</sup>). At the same time, the needed moisture for plant growth is retained. Natural fiber logs can be molded to fit the bank line, and are anchored by wooden stakes or rock footers. Bio-logs can be planted or covered with plant seeds. The unit price for bio-logs is approximately \$6 per linear foot for materials and installation.

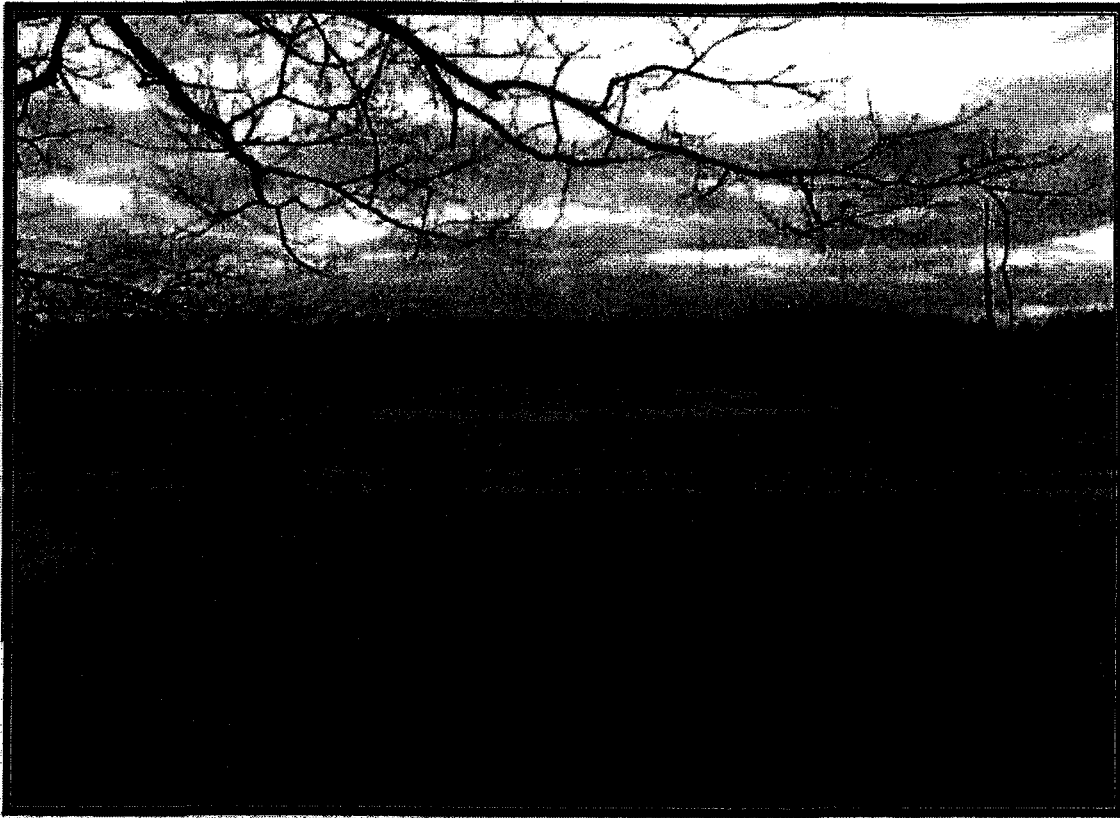
**Looking southeasterly Taylor River Estuary salt marsh from the northbound rest area on I-95 as how the subject pond might look in the After Situation after the dam removal.**
